Koshi Flood Disaster

This report provides a preliminary assessment of the impacts of the Koshi flood disaster and rainfall forecasts for the next three days.

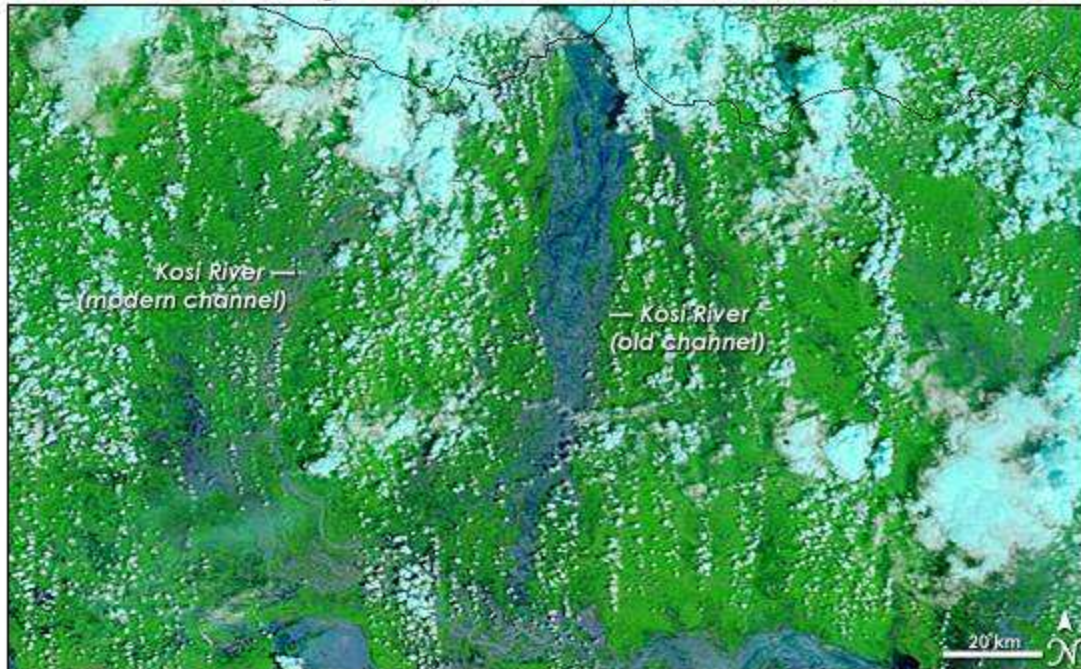
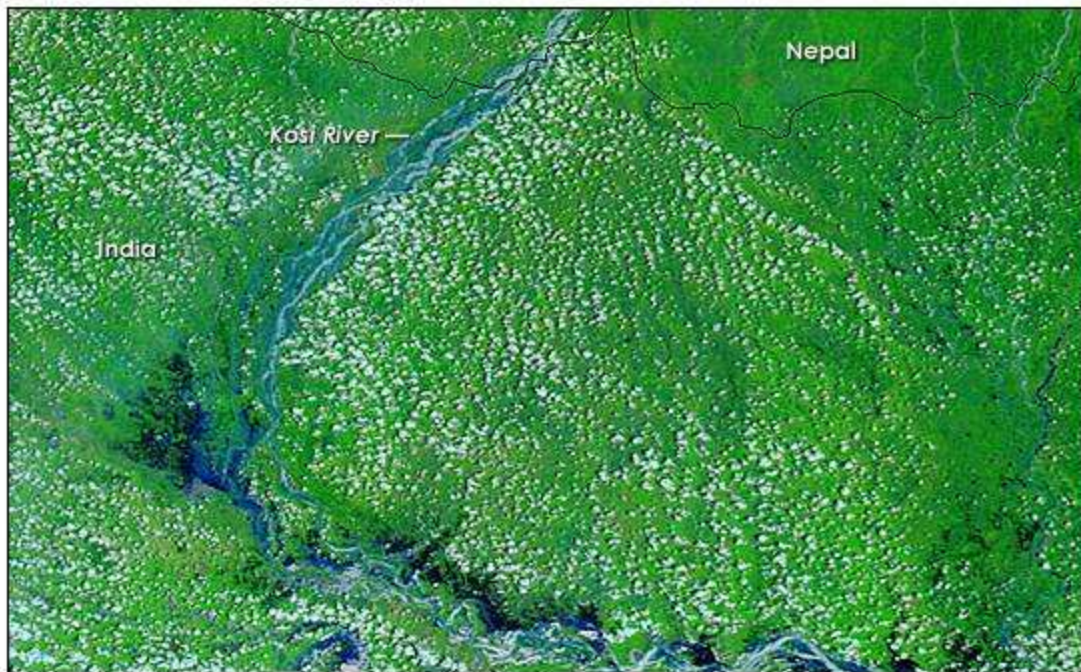
August 24, 2008

August 8, 2008

Figure 2 Satellite images of the Koshi River before and after the breach of the embankment

When we compare the satellite images with Figure 1 which documents the change in course of the Koshi River the current flow of the river after the embankment breach is following the course of around 1926.
